Previously published in Proceeding of the 30th Symposium on Engineering Geology and Geotechnical Engineering, 1994, "Hydrogeology, Waste Disposal, Science and Politics," p. 121-135.

Geologic and Geotechnical Investigation of the Windsor Park Subdivision North Las Vegas, Nevada

Lorraine M. Linnert, James L. Werle, C.E.G.
Alan N. Stilley, P.E. and Brad L. Olsen, E.I.T.
Converse Consultants Southwest, Inc., Las Vegas, Nevada

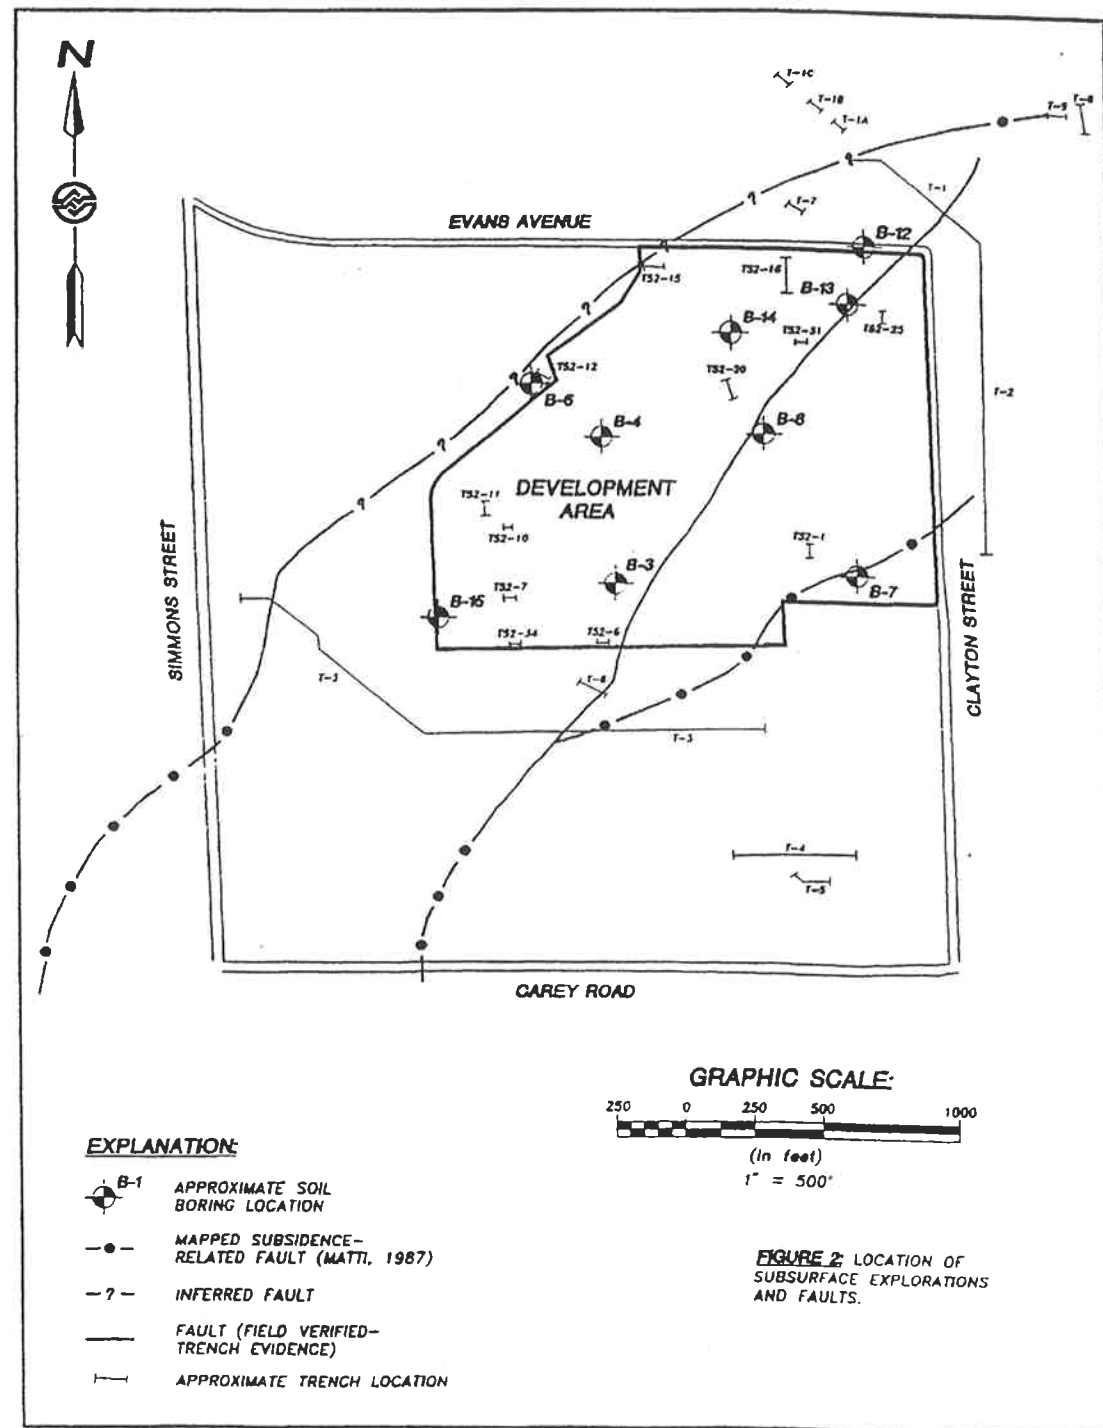
The site was constructed on the juncture of two fault scarps trending southwest-northeast across the Windsor Park Subdivision (Matti, et. al., 1987). The location of these fault scarps is shown on Figure 2. These fault scarps are generally believed to be topographic expressions of subsidence-related faults that extend throughout the Las Vegas Valley. They are generally thought to be nontectonic features of Quaternary Age (Cibor, 1983). Although several authors (Bell and Price, 1991) have noted that the fault escarpments may be tectonic in origin (from faults extending up from the bedrock basement underlying the valley and capable of generating seismic events), these fault scarps are most commonly thought to be the surface expressions of prehistoric differential consolidation or compaction of alluvial and playa-like sediments having dissimilar grain-size and compressibility characteristics. Therefore, the faults are not capable of generating earthquakes although they may be partially induced by an earthquake event (Bell, 1981).

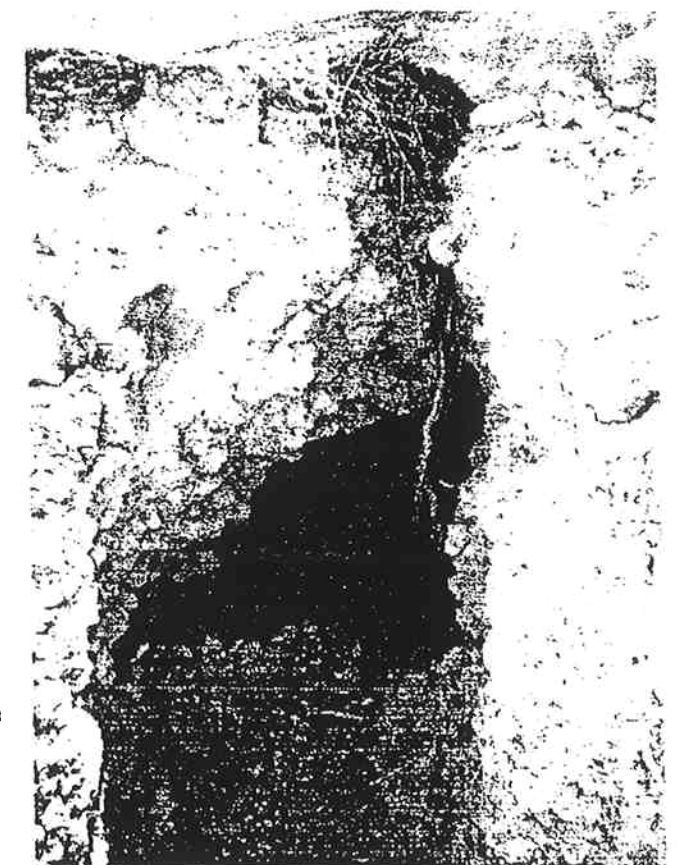
Figure 3. Fissure located beneath caliche cap in trench T-5
